**Community Environmental Response  
Facilitation Act (CERFA) Report**

**Hamilton Army Airfield  
Novato, California**

**U.S. ARMY ENVIRONMENTAL CENTER  
ABERDEEN PROVING GROUND, MARYLAND 21010**

**April 1994**

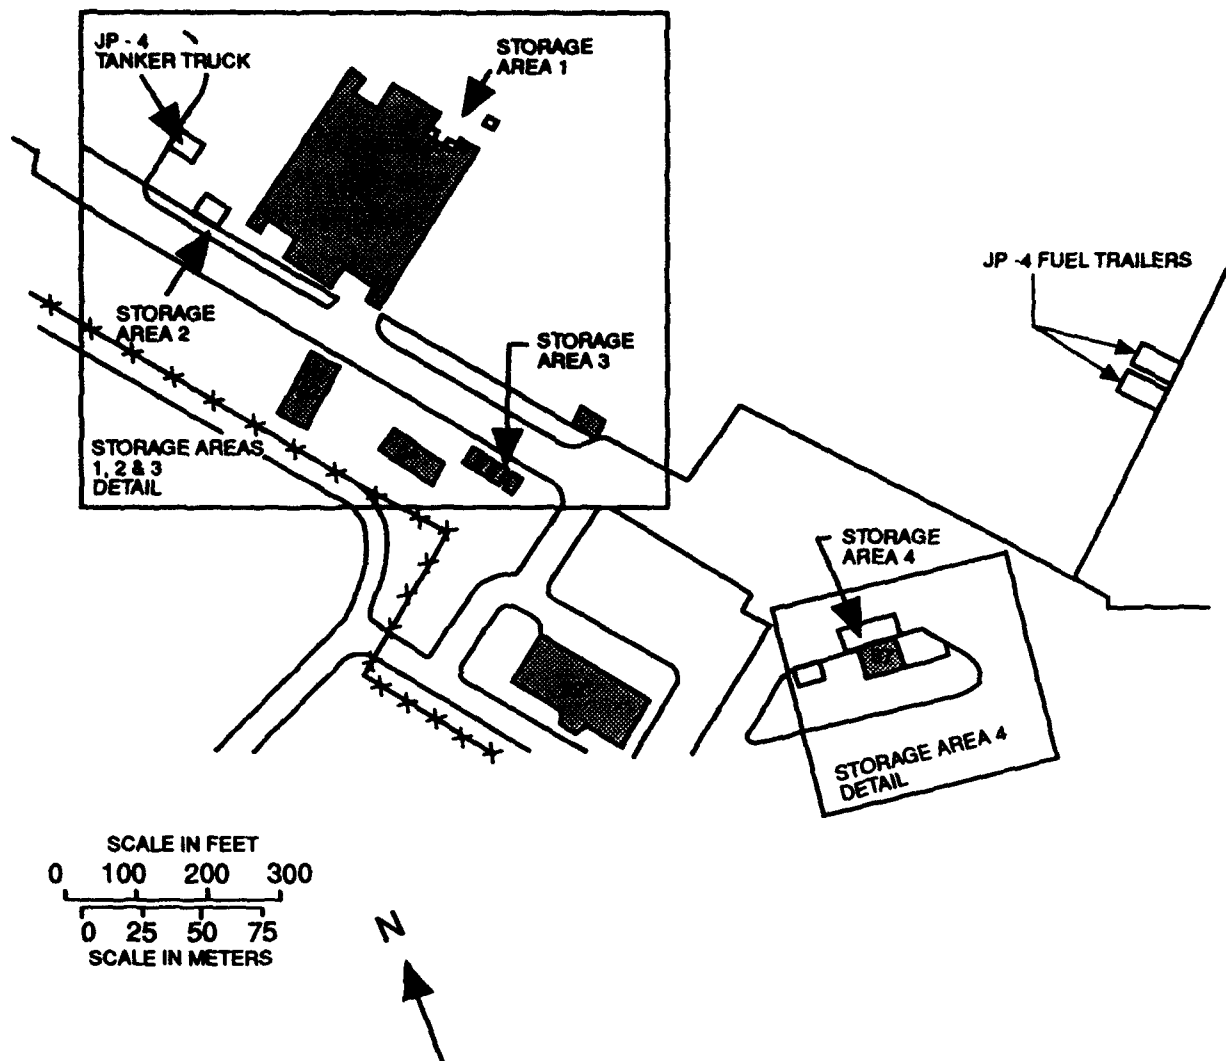
FIGURE 3-1

# Aircraft Maintenance Storage Area Locations
